White Rust: Its Causes and Prevention

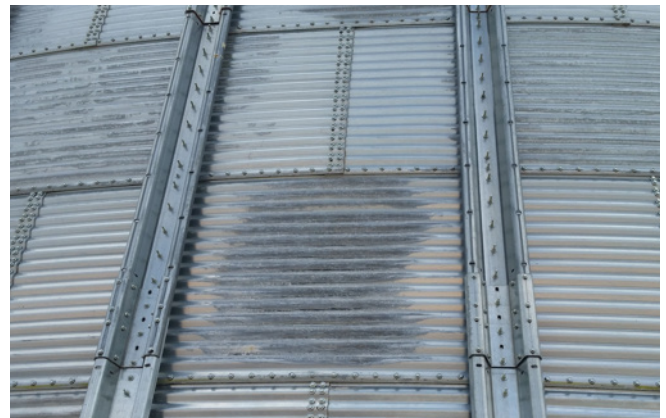
Figure 2: Example of improperly stored silo wall sheets

The progression of white rust can begin quickly upon the introduction of moisture into stacked bundles of parts. Within days, the zinc layer will begin to corrode. Figure 2 shows silo wall sheets that were not protected from the elements while waiting to be installed.

Within a matter of weeks, red rust (iron oxide) may begin to form, at which point the parts will require inspection for structural stability.

Bolt holes allow moisture to penetrate easily into the layers of the bundle, providing a ready environment for rust formation. Consequently, wallsheet and roof bundles must be stored in warehouses and elevated at least 2 inches (5 cm) above ground level. Condensation from the ground itself may also penetrate wallsheet bundles, creating a moist environment conducive to white rust.

If a jobsite does not offer indoor storage, preventive steps must be taken. Wallsheets should be inverted to a convex (curved down) configuration, with wood lathe placed between individual sheets. This will allow surface moisture to evaporate and encourage air flow between sheets. Roof panels benefit by a similar method of separation with lathe between panels.

Caution should be exercised when placing plastic or tarpaulins over bundles. Though these barriers form an effective deterrent to precipitation, they can also create an environment that traps moisture in the bundles. Coverings such as these are advisable only for very short periods of time.

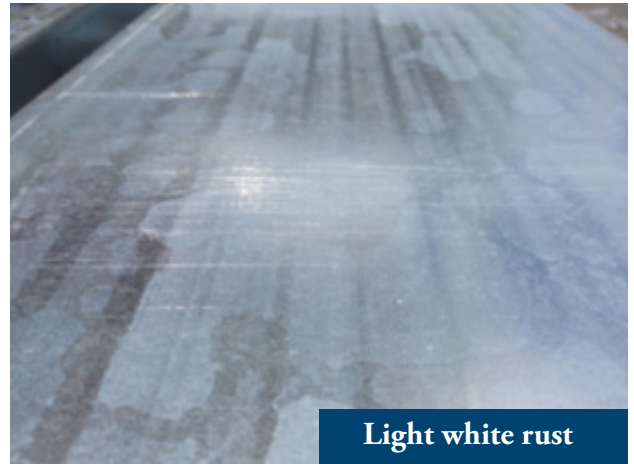
Light white rust: This condition is characterized by a light white haze covering the face of the parts. At this amount, white rust poses little threat to the zinc coating. Exposed to normal environmental conditions, this type of white rust will naturally wash off in rain and the passivated layer will re-form naturally.

Light white rust

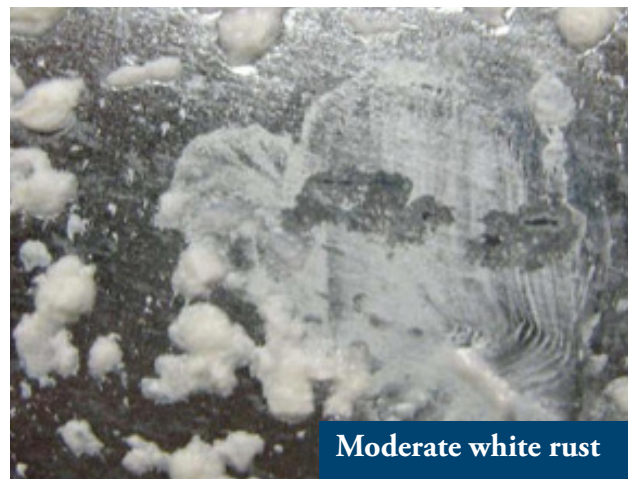
Moderate white rust

Moderate white rust: This condition is characterized by a heavier, chalky coating on the galvanized parts, and it calls for remedial action. An Oakite®31 (or vinegar) solution should be applied using a brush or other lightly abrasive pad, rinsed and allowed to dry. The part should then be painted with a light film of aluminum-based paint. This will reinforce the remaining zinc layer and protect the base steel layer.

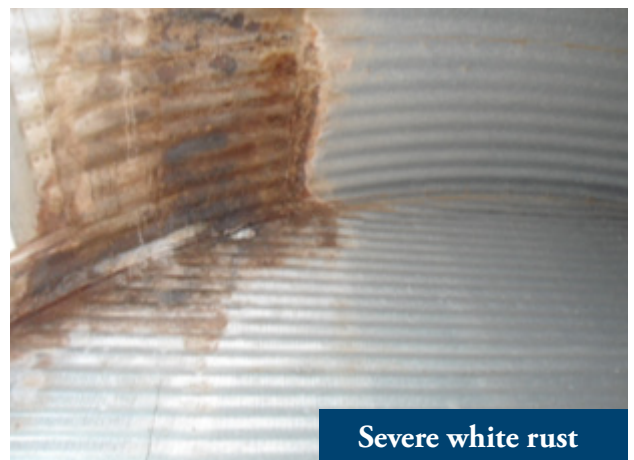
Severe white rust

Severe white rust: This condition is characterized by a thick, chalky coating, possibly with signs of a black powdery coating or, if most severe, red rust. In some cases, the parts may even be stuck together. At this point, the zinc coating has been removed and the base steel is beginning to corrode. If caught before the black powder forms, the part may be re-passivated by applying the same Oakite® 31 (or vinegar) solution and applying zinc-based epoxy paint or cold-galvanizing compound. If a black powder has formed, replacement parts should be ordered and the damaged parts removed from service.
