White Rust: Its Causes and Prevention

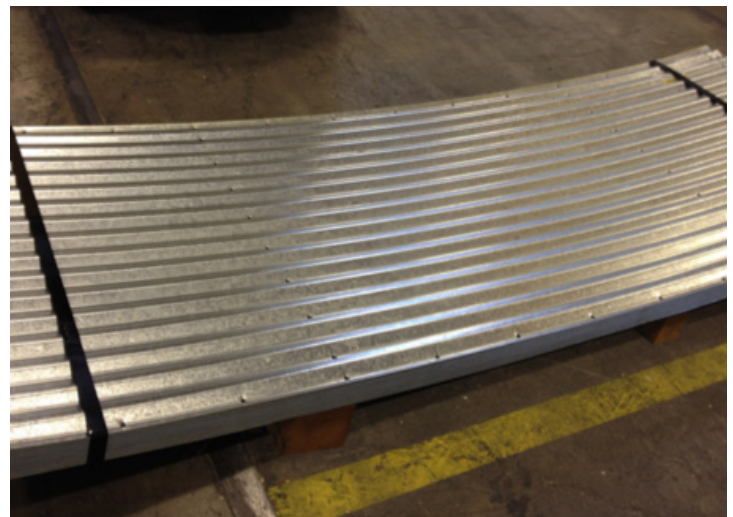
Figure 3: New silo wall sheets ready for shipment

Due to their unique shapes, grain silo parts are especially susceptible to white rust. Wallsheet bundles are shipped in a concave (curved upward) configuration to provide stability and prevent distortion. This configuration also provides a natural gutter effect to the bundles. Figure 3 shows a typical silo wall sheet bundle at the factory. Note the shiny surface and orientation of the sheets.

Bolt holes allow moisture to penetrate easily into the layers of the bundle, providing a ready environment for rust formation. Consequently, wallsheet and roof bundles must be stored in warehouses and elevated at least 2 inches (5 cm) above ground level. Condensation from the ground itself may also penetrate wallsheet bundles, creating a moist environment conducive to white rust.

If a jobsite does not offer indoor storage, preventive steps must be taken. Wallsheets should be inverted to a convex (curved down) configuration, with wood lathe placed between individual sheets. This will allow surface moisture to evaporate and encourage air flow between sheets. Roof panels benefit by a similar method of separation with lathe between panels.
